MultiPlus-II 8kVA & 10kVA internal AC fuse replacement

Applies to MultiPlus-II 48V 8000 & 10000 - 230V

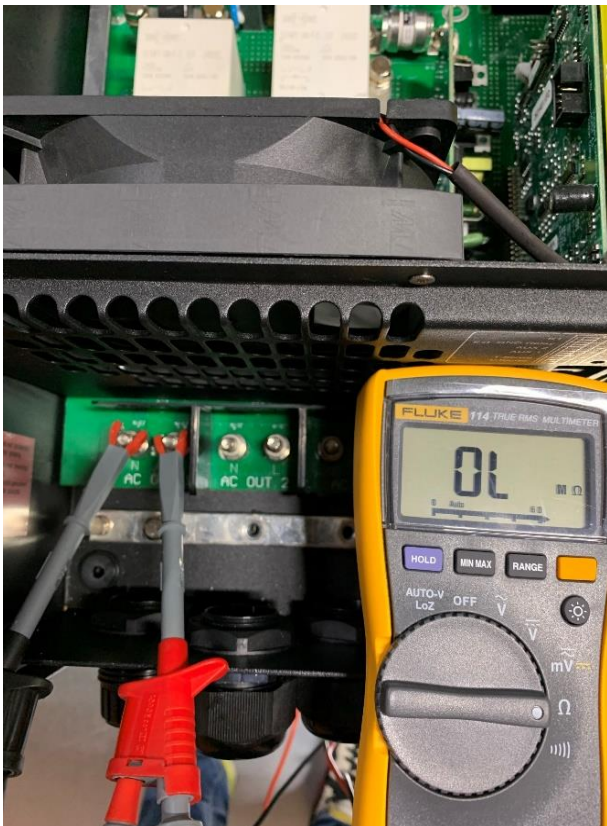
To double check, use a multimeter to measure the resistance between the AC OUT-1 L and N terminals.

- If the multimeter reads (near to) '0' Ohm; the internal AC fuse is OK.
- If the multimeter reads Open or 'OL'; the internal AC fuse is blown and needs to be replaced.

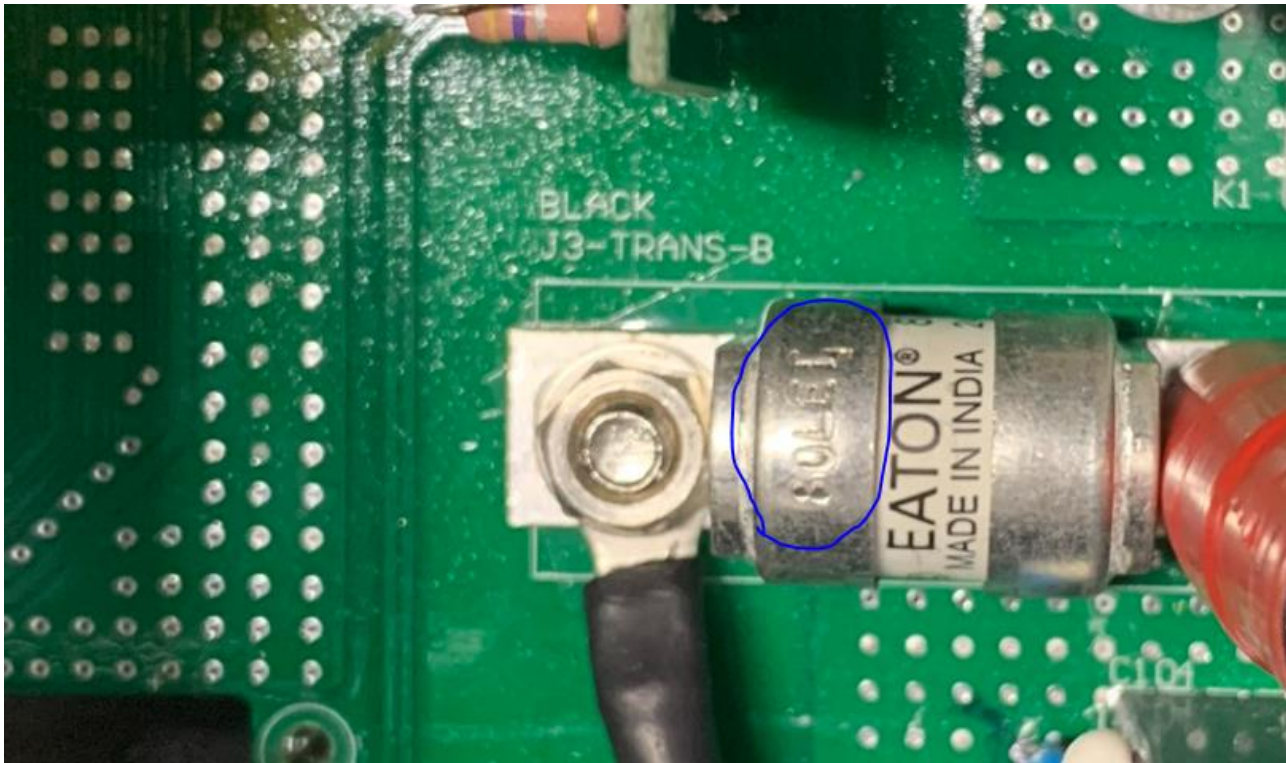
When mounted like in this first picture, the rating can be seen impressed in the metal part on the left:

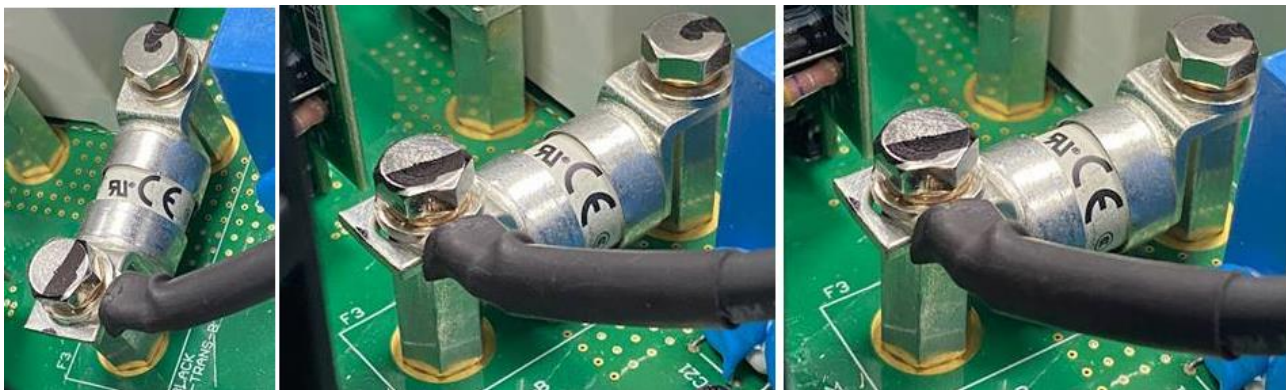
When mounted up side down and with (brass nickel) coupling nut, like in this next photo, it is 125A – always. And does not need replacing, even when failed. See also next chapter.

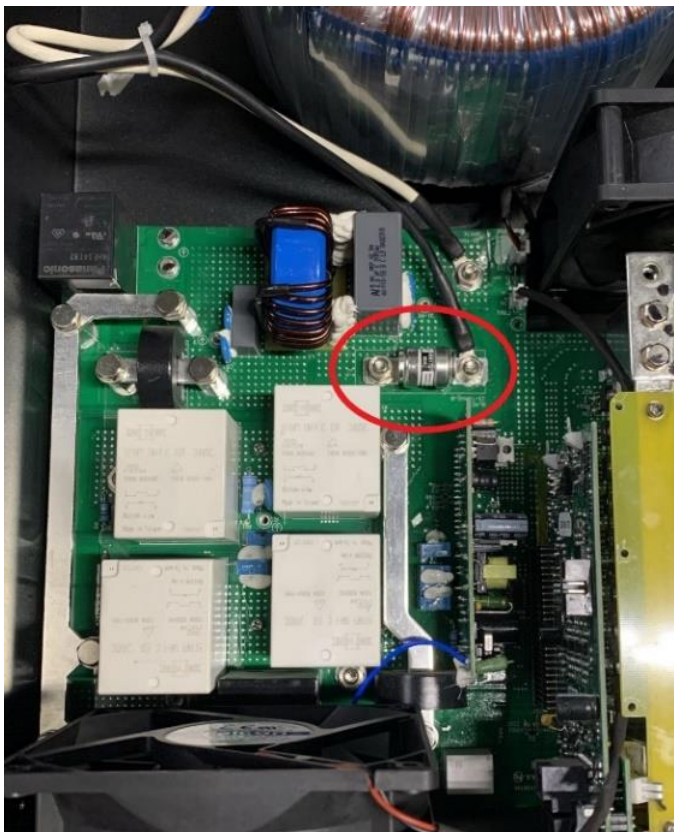
The fuse that needs replacing is F3. Location of the fuse is encircled in red in below photo. Use a 10mm socket with a torque wrench with extension. No soldering is needed. Required torque when fastening the nut is 6 Nm.

Note that the new fuse leaves little space for the nut, it requires a relatively thin socket. See also next chapter.

The required fuse is the 125LET (125A 240V AC BS88), from EATON. This will replace the 80LET (80A) fuse. If necessary, these fuses can be supplied by Victron Almere.

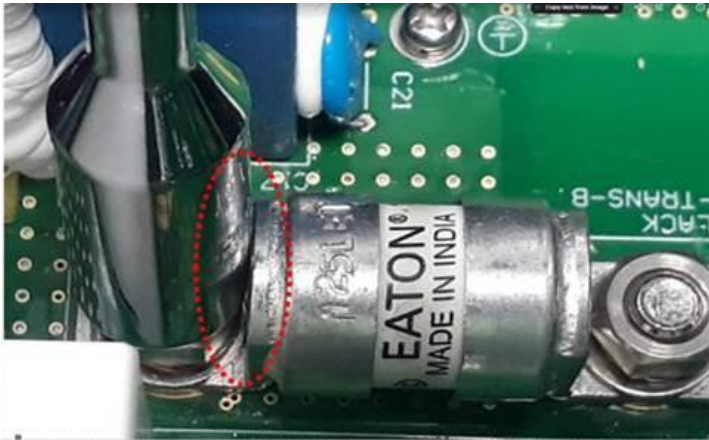
There is a variance in the 125A fuse body dimension that can lead to the socket not fitting properly on the nut.

When using the 125LET Eaton fuse you probably will observe this obstruction encircled in red in below photo.
