1. Summary

2. Affected models and serial numbers

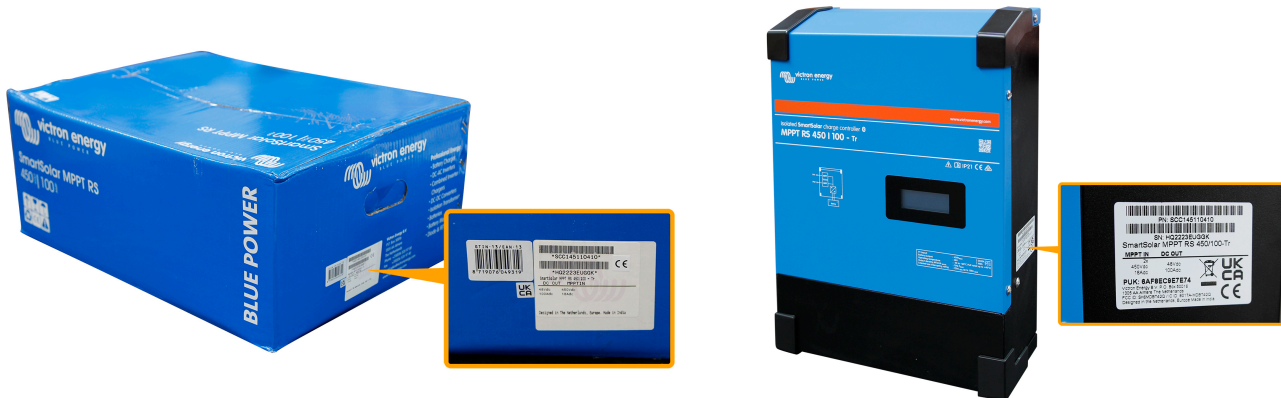
The serial number (SN) can be found on the label on the enclosure, on the VRM Portal in the Device list, as well as on the label on the carton and in the VictronConnect App.
