Over riding the OBC in a Golf Cart for Charging Purposes

Instructions for 'How to override the OBC'

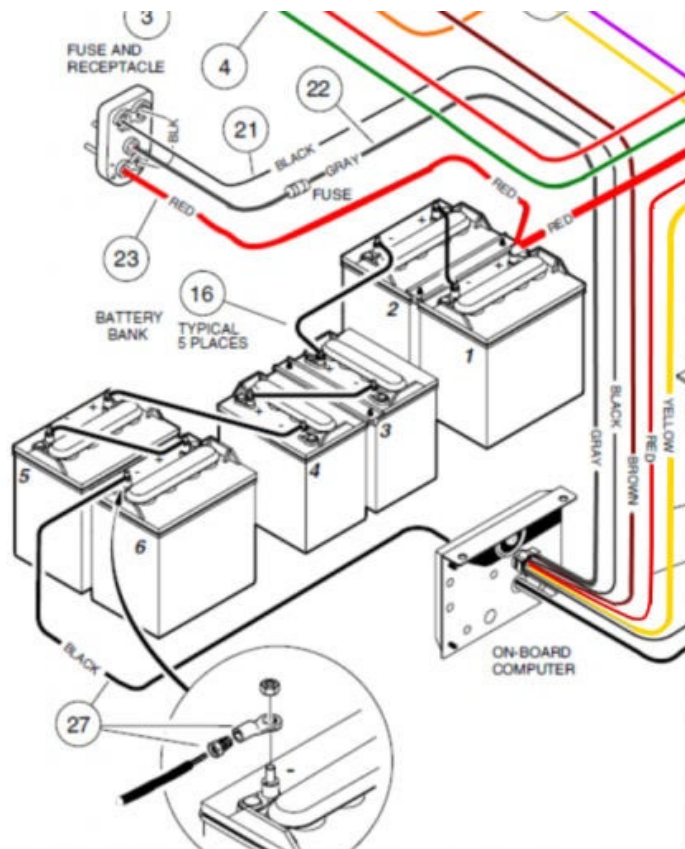
Some model Clubman have a OBC (On Board Computer) which requires the genuine Clubman charger. If your Delta Q shows an E013 Alarm on installation, it may be due to the OBC.

Alarm	E013	Charger Output Current Not Accepted	Battery voltage is detected but the charger is unable to output current. This is normally caused by an electrical device connected between the charger and the battery which passes through voltage but not current. Poor connections can also cause this. Ensure the charger is properly connected to approved equipment. This error will automatically clear once the charger is reset by cycling DC or AC.
-------	------	-------------------------------------	---

This image is of a 48 volt Club Car golf cart wiring diagram. You can clearly see three sets of batteries each of which is 8 volts. The batteries are numbered 1 through 6 and connected in series (positive to negative) to create the needed 48V output. In the lower right corner, you will see all the wiring running through the on-board computer. The upper left corner depicts the backside of the charge receptacle.

Now look at battery number 6 in the lower left corner. To bypass the OBC you will need to connect a 12-gauge black wire from the negative terminal of this battery to where the black wire attaches to the back of the receptacle. That's it folks; you are done!

Your charger should now be able to sense voltage and properly charge the cart. The Layman's science for what you just accomplished is easy: you created a circuit or a loop. Notice how there was a red positive wire coming off battery #1 going directly to the back of the receptacle? But before you added this bypass there was no negative black wire coming directly from the battery bank to the back of the receptacle. It had to first go through the onboard computer before reaching this location.
